Appendix C

Photograph Log

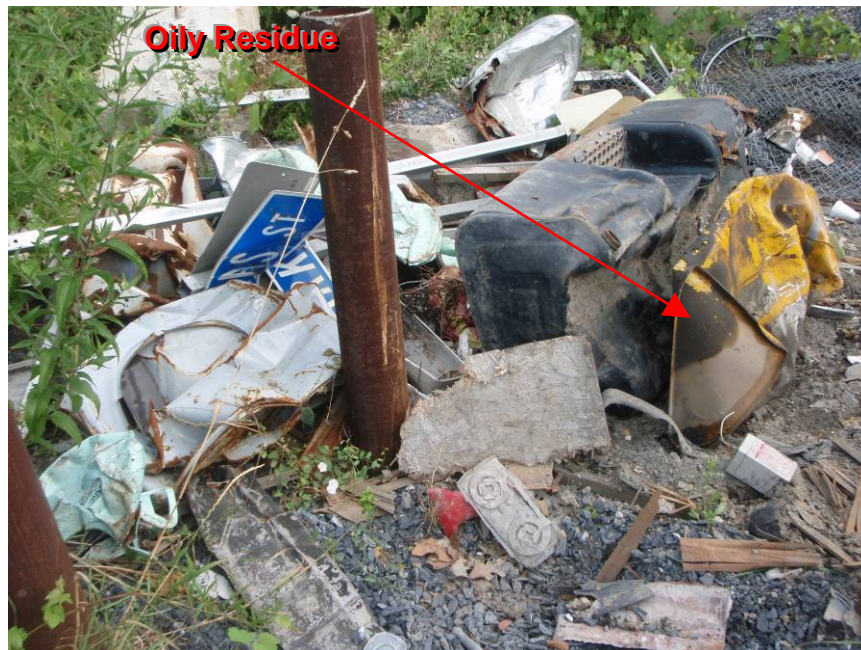
Photograph 40. Public Works Facility – Trash, debris and metal parts stored without cover or containment in debris pile shown in Photograph 38.

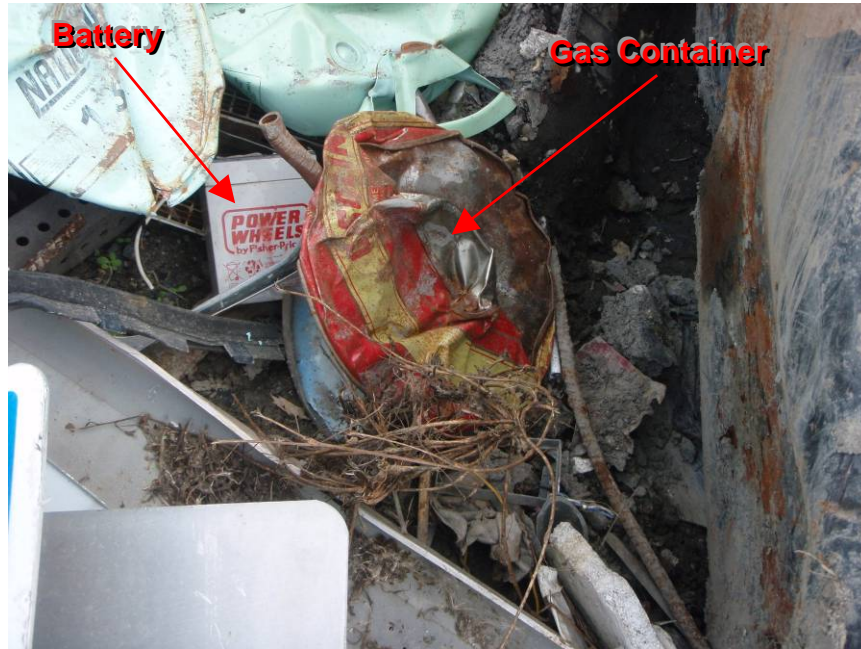
Photograph 41. Public Works Facility – Additional view of trash, debris and metal parts stored without cover or containment in debris pile shown in Photograph 38.

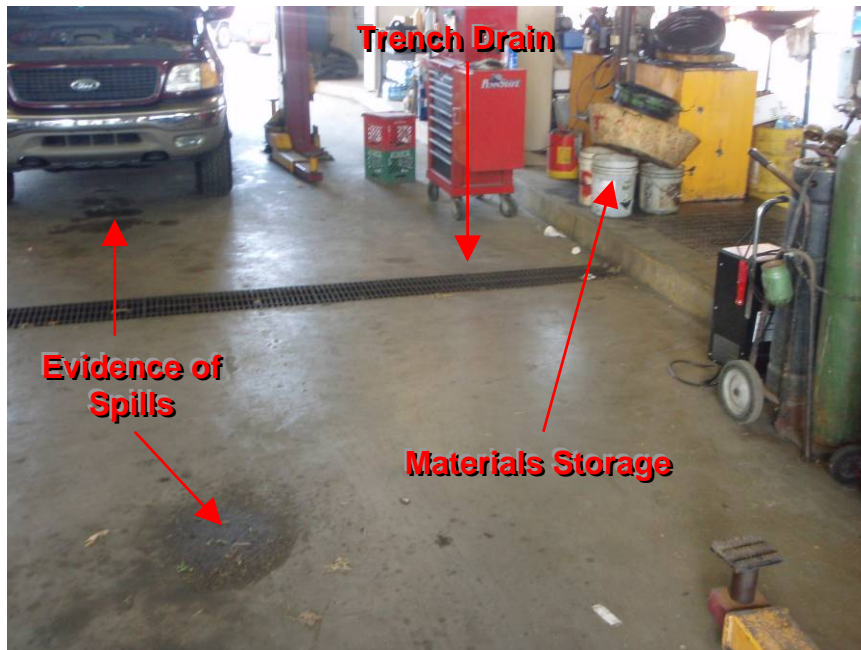
Photograph 42. Public Works Facility – View of trench drain in vehicle maintenance building. Note storage of materials and evidence of previous spills.

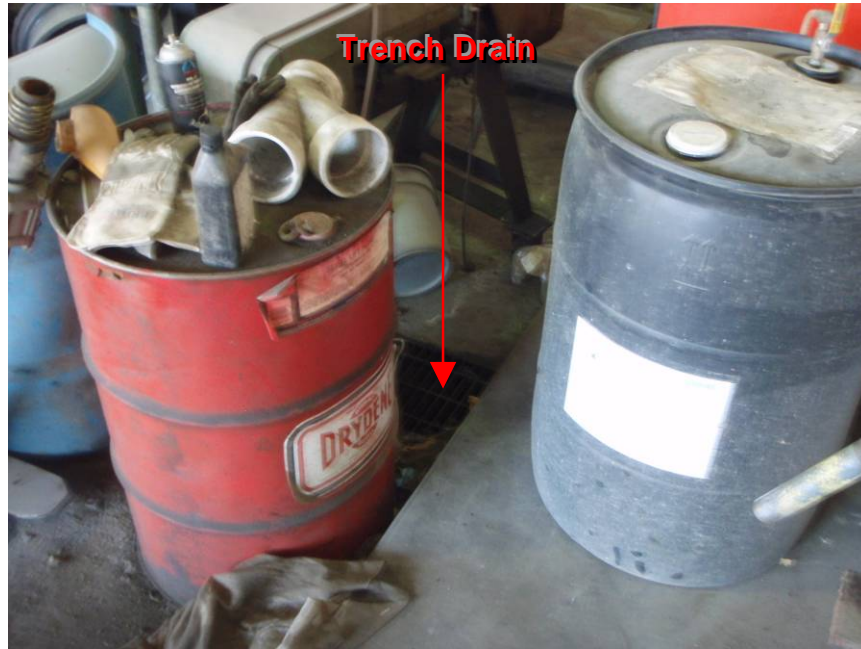
Photograph 43. Public Works Facility – 55-gallon chemical drums stored without cover or containment adjacent to trench drain in vehicle maintenance building.

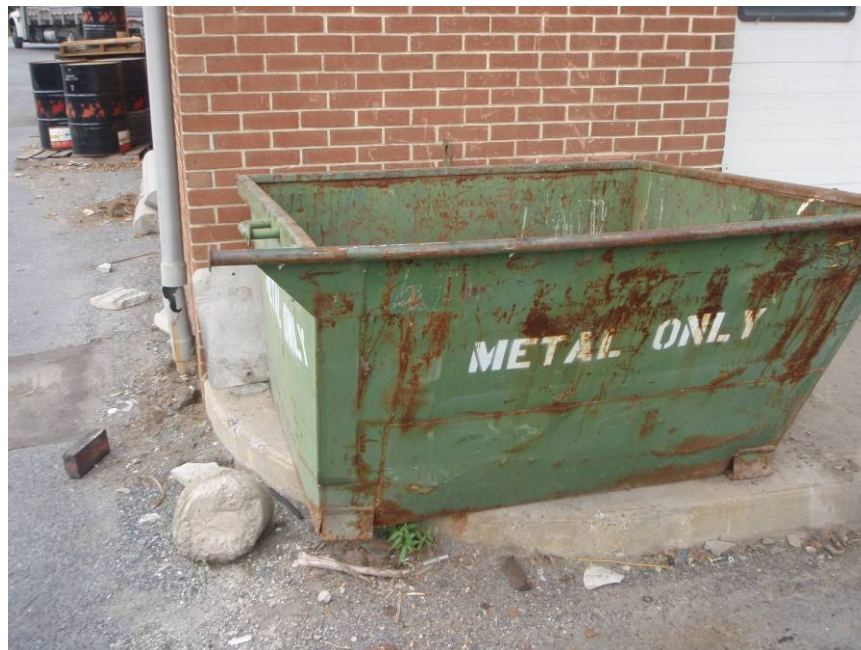
Photograph 44. Public Works Facility – Uncovered metal materials waste storage bin adjacent to vehicle maintenance building.

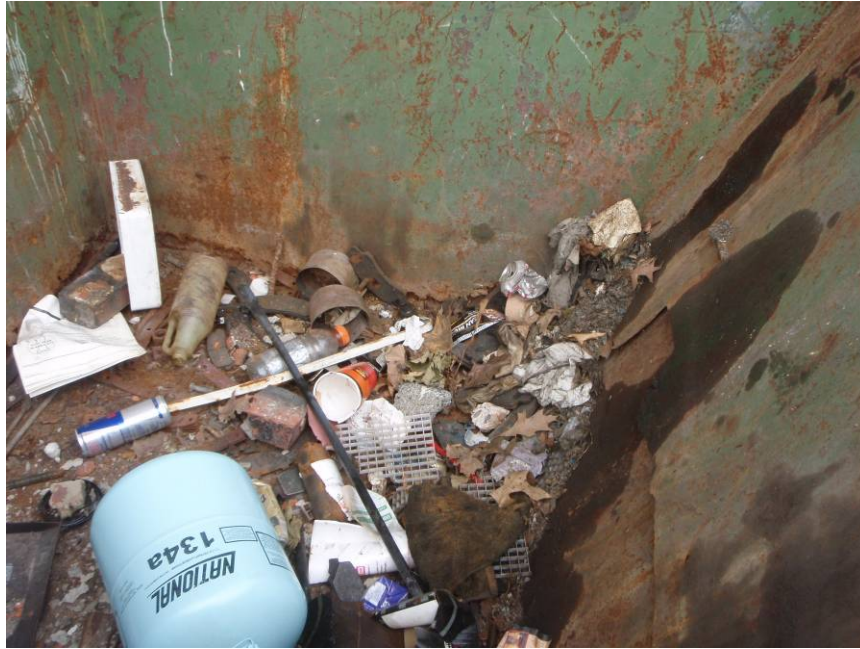
Photograph 45. Public Works Facility – View into metal materials waste bin shown in Photograph 44. Note staining on wall of bin.

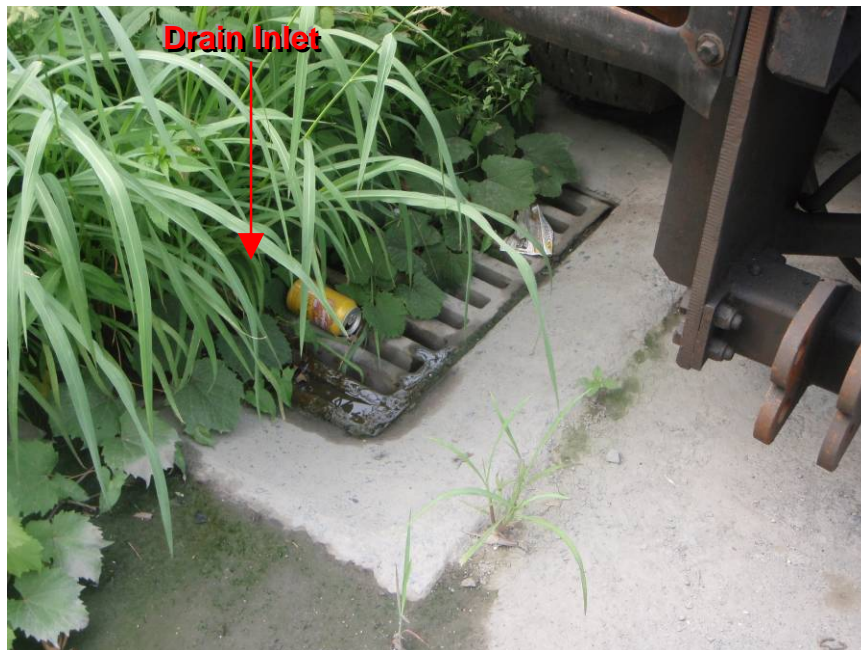
Photograph 46. Public Works Facility – Drain inlet located downgradient of metal materials waste bin shown in Photographs 44 and 45.

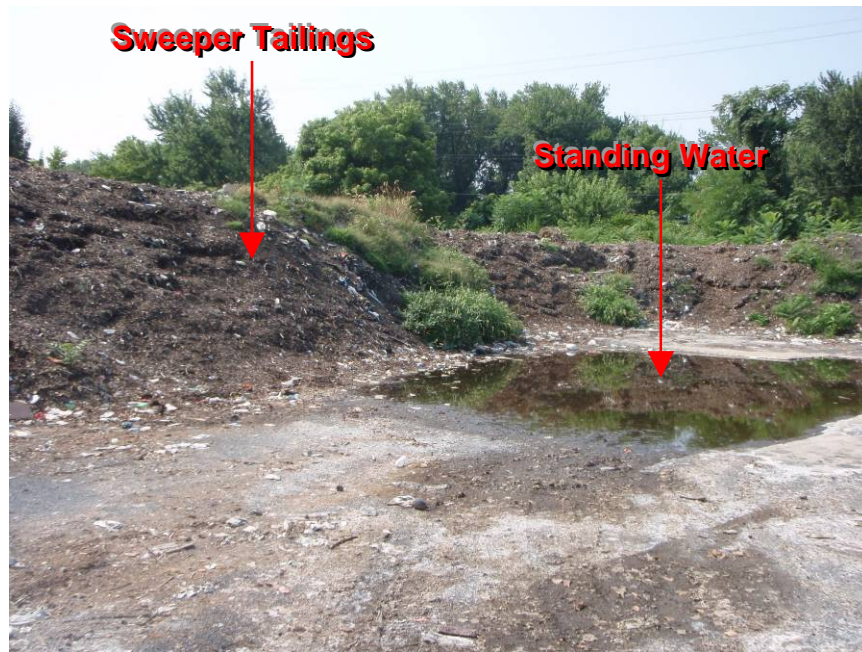
Photograph 47. Sweeper Tailings Disposal Site – View of sweeper tailings piles and adjacent standing water. Note trash and debris adjacent to sweeper tailings piles.

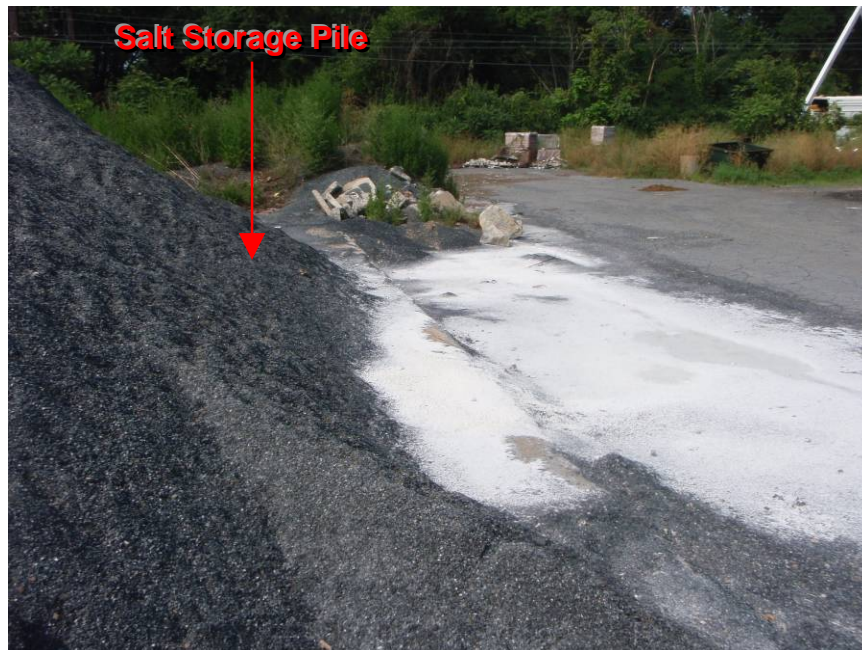
Photograph 48. Sweeper Tailings Disposal Site – View of northwest side of salt storage pile at site. Note evidence of salt transport from salt storage pile.

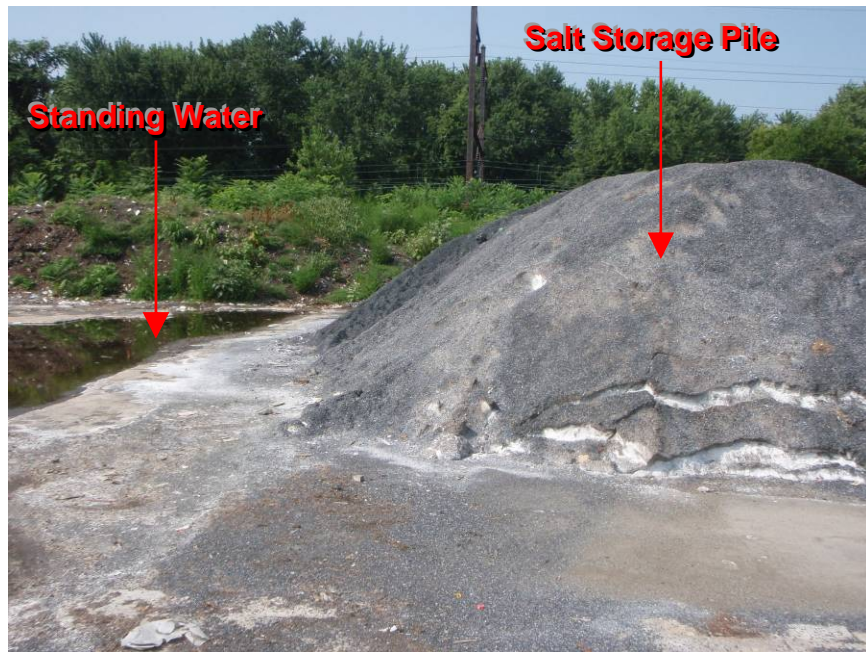
Photograph 49. Sweeper Tailings Disposal Site – Additional view of salt storage pile and adjacent standing water.

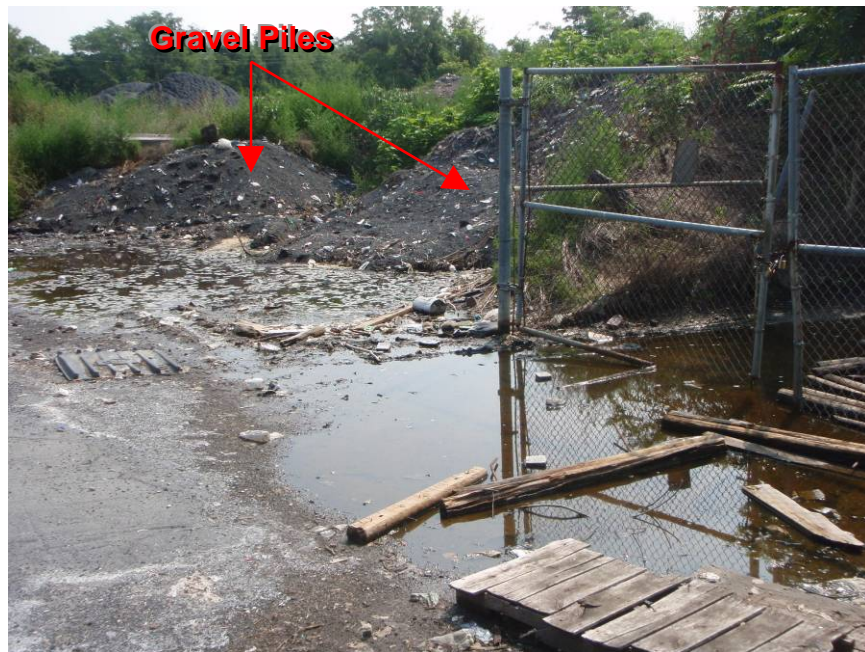
Photograph 50. Sweeper Tailings Disposal Site – View of gravel piles and trash and debris on ground surface and in standing water along southern edge of site.

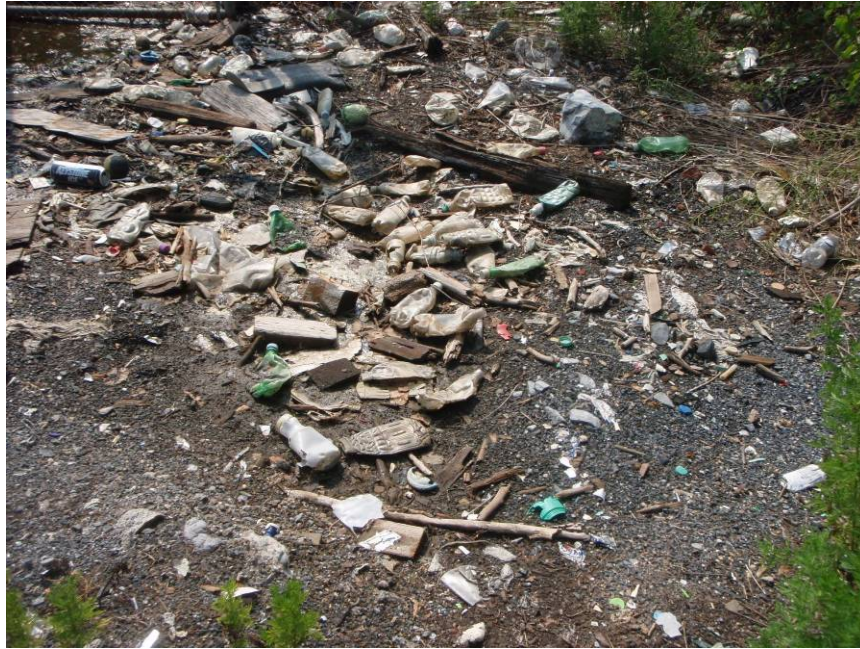
Photograph 51. Sweeper Tailings Disposal Site –View of trash and debris on ground surface near southern edge of site.

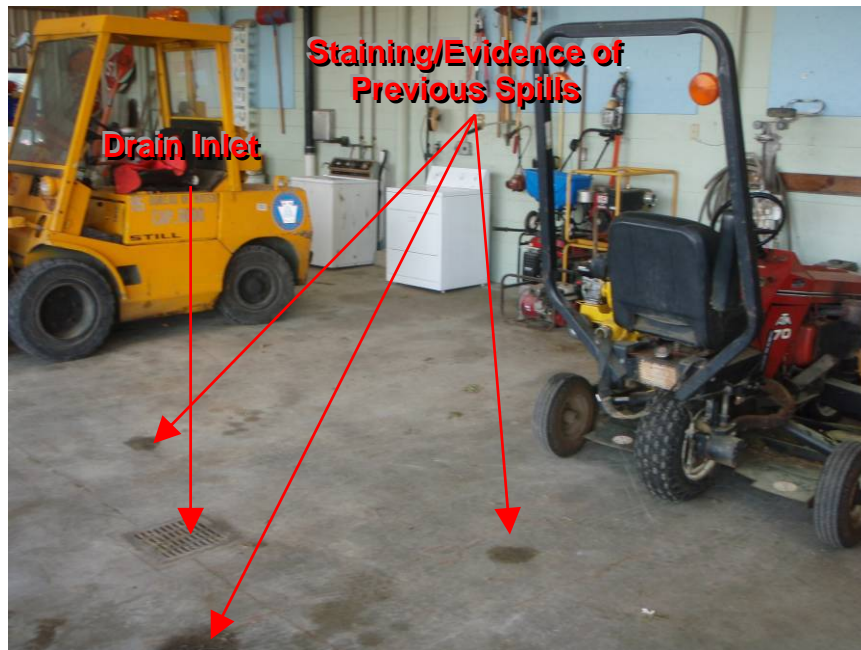
Photograph 52. Water Treatment Facility – Staining and evidence of previous spills on impervious ground surface adjacent to floor drain inlet in maintenance shop building.

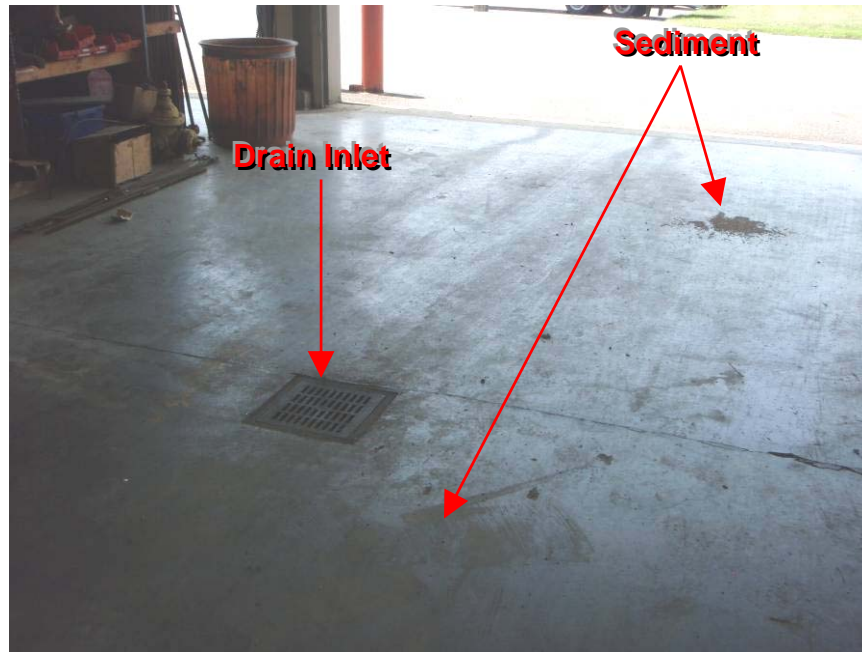
Photograph 53. Water Treatment Facility – Sediment on impervious ground surface adjacent to floor drain inlet in maintenance shop building.

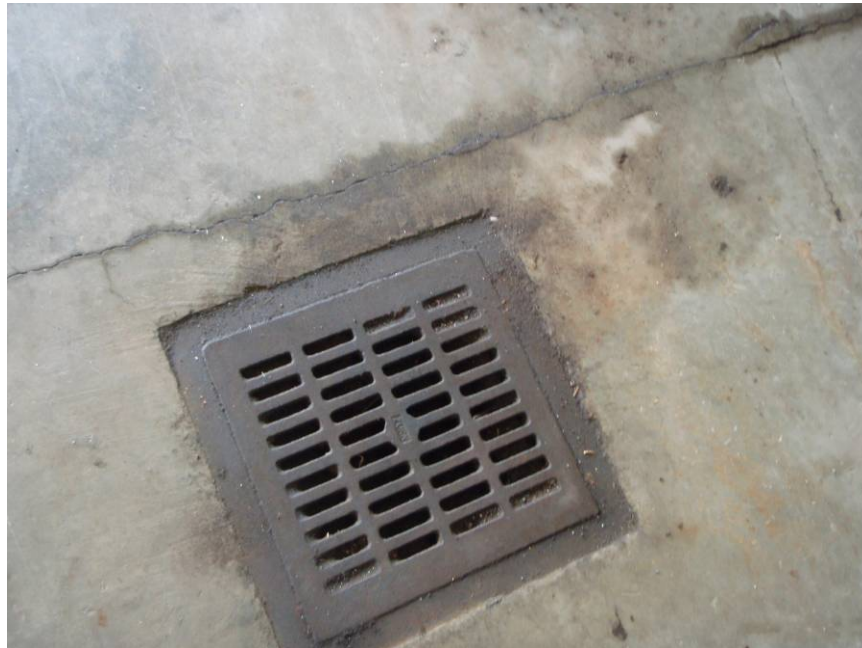
Photograph 54. Water Treatment Facility – Close-up of floor drain inlet in maintenance shop building. Note staining around the inlet.

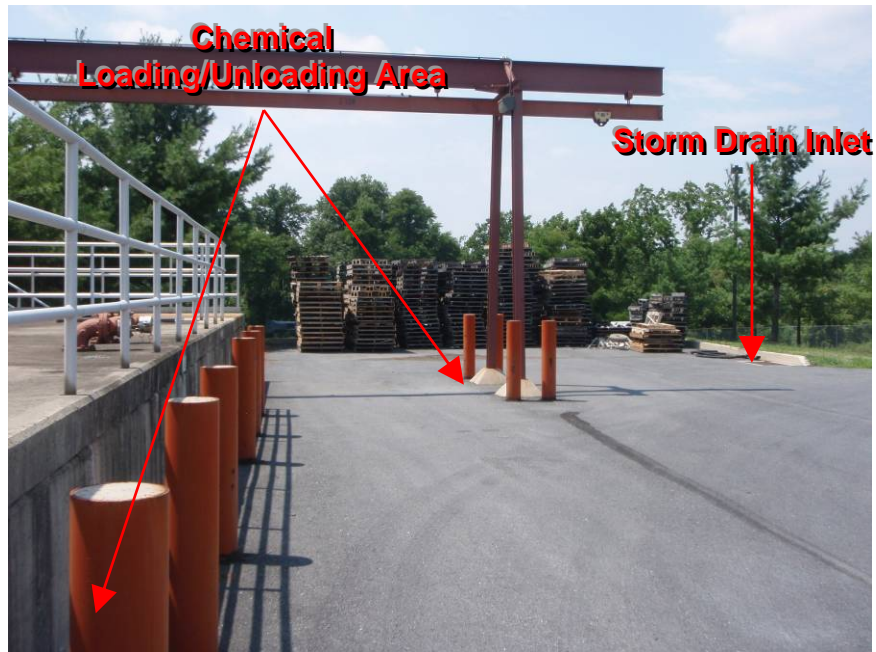
Photograph 55. Water Treatment Facility – View of chemical loading/unloading area. Note proximity to storm drain inlet.

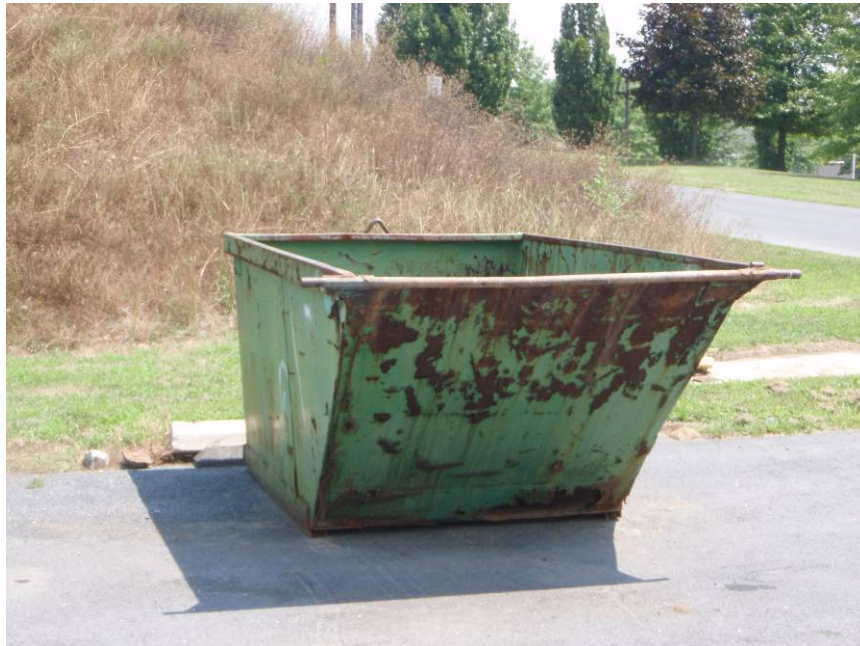
Photograph 56. Water Treatment Facility – View of uncovered waste container on south side of maintenance shop building.

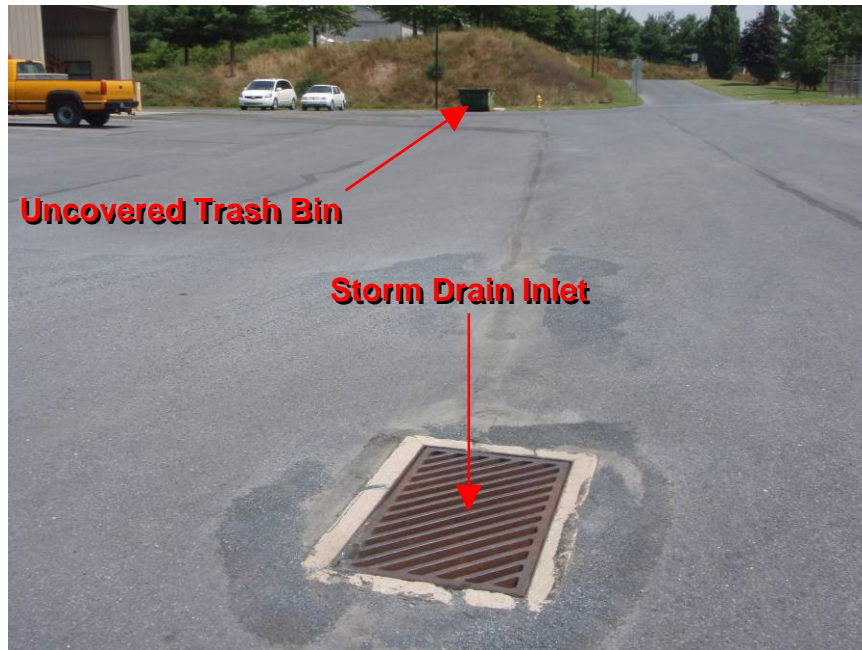
Photograph 57. Water Treatment Facility – View from storm drain inlet to upgradient, uncovered waste container shown in Photograph 56.

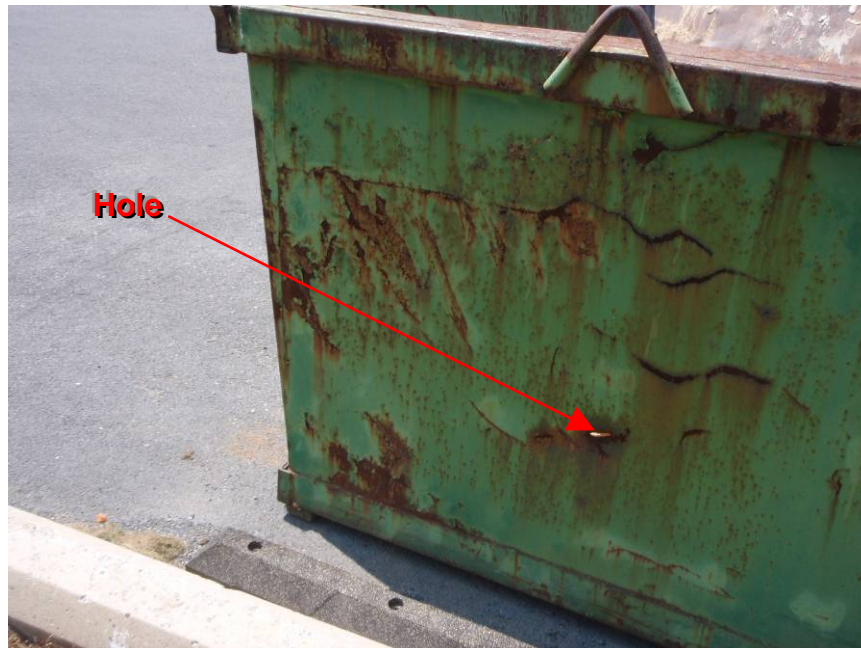
Photograph 58. Water Treatment Facility – Example of hole observed in side of waste container shown in Photographs 56 and 57.

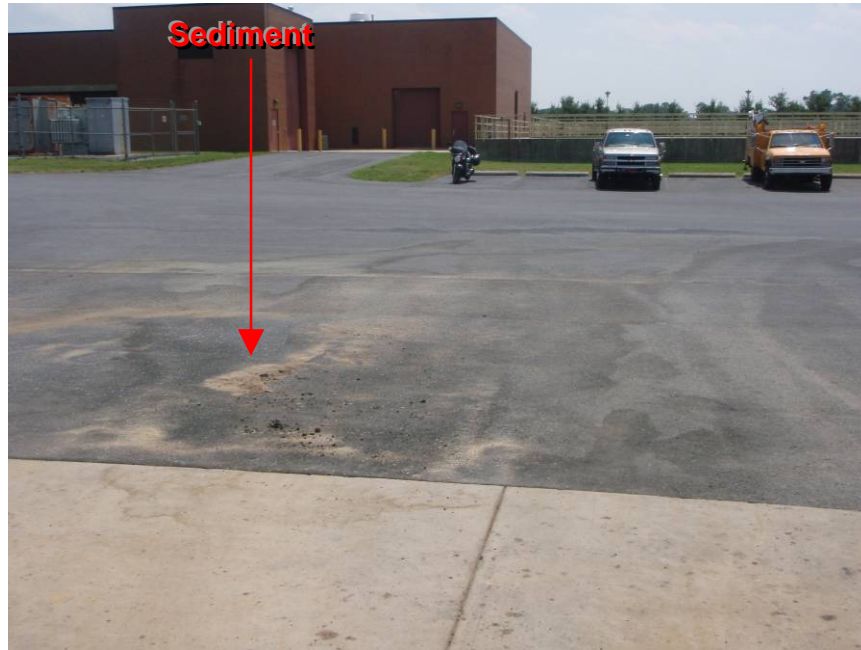
Photograph 59. Water Treatment Facility – View of sediment and staining on impervious ground surface outside southern garage entrance to maintenance shop building.

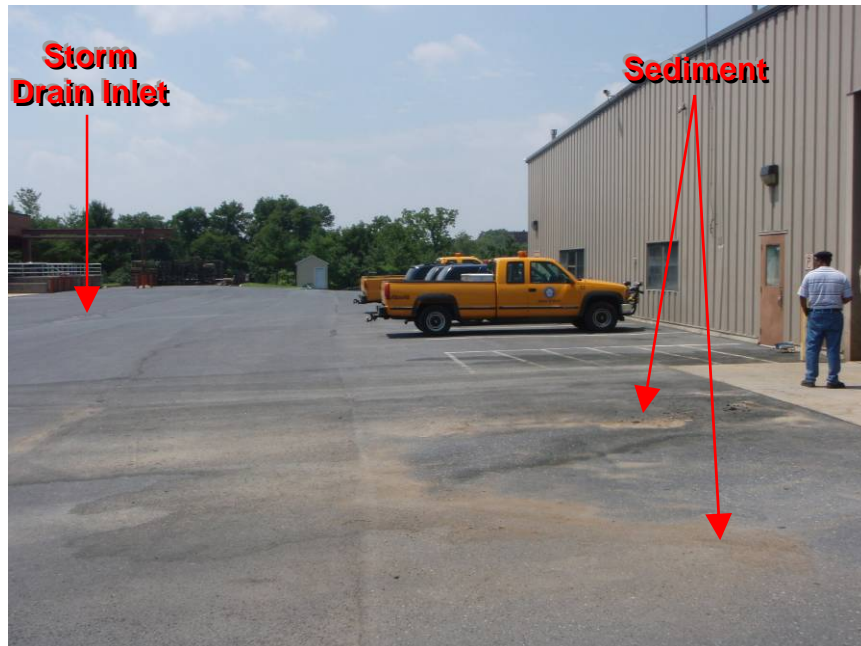
Photograph 60. Water Treatment Facility – View toward storm drain inlet to west from area of sediment accumulation shown in Photograph 59.
